EQUIPMENT DATA SHEET

Unit Designation: Isotope Exhaust Fan 003

PREDICTIVE MAINTENANCE PROGRAM

Description: Isotope Exhaust Fan 003

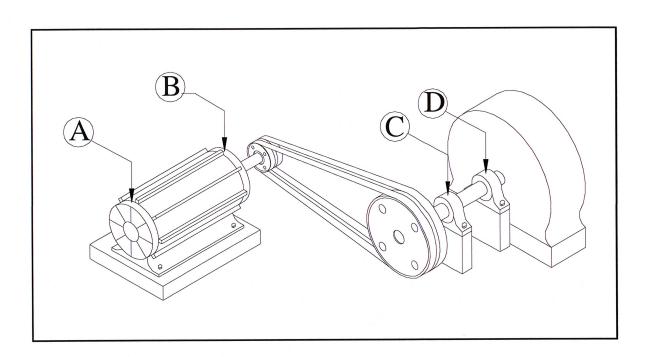
The overall vibration levels are excessive due to worn belts, misaligned sheaves, and fan unbalance. Our visual inspection revealed that two of three belts are worn and cracked, the motor sheave is badly worn due to improperly tensioned belts, and the sheaves are misaligned.

Our spectral analysis indicates both motor bearings lack lubrication and show slight to moderate wear. However, they are both sealed and cannot be re-lubricated; further monitoring is required to determine the rate of deterioration and appropriate timing for replacement.

Both fan bearings are in good condition and adequately lubricated.

Our belt drive analysis indicates this unit is under-belted with the use of 5V belts. The situation is easily corrected however, by specifying 5VX belts at the next replacement.

- 5 Replace the motor sheave.
- 5 Replace the belts with 5VX Opti-Belts (or another premium belt). Accurately align the sheaves and set the belt tension to the minimum level required to avoid slippage on start-up.
- 4 Have the fan balanced following the belt and sheave change (if you need assistance, Vibtech offers on-site balancing).
- O Continue monitoring the motor bearings to determine appropriate timing for replacement.
